Contractor Yard  
City of Buena Park  
Chip Seal with PG70-22TR

*Applied in 2007*

Pictures taken in 2010

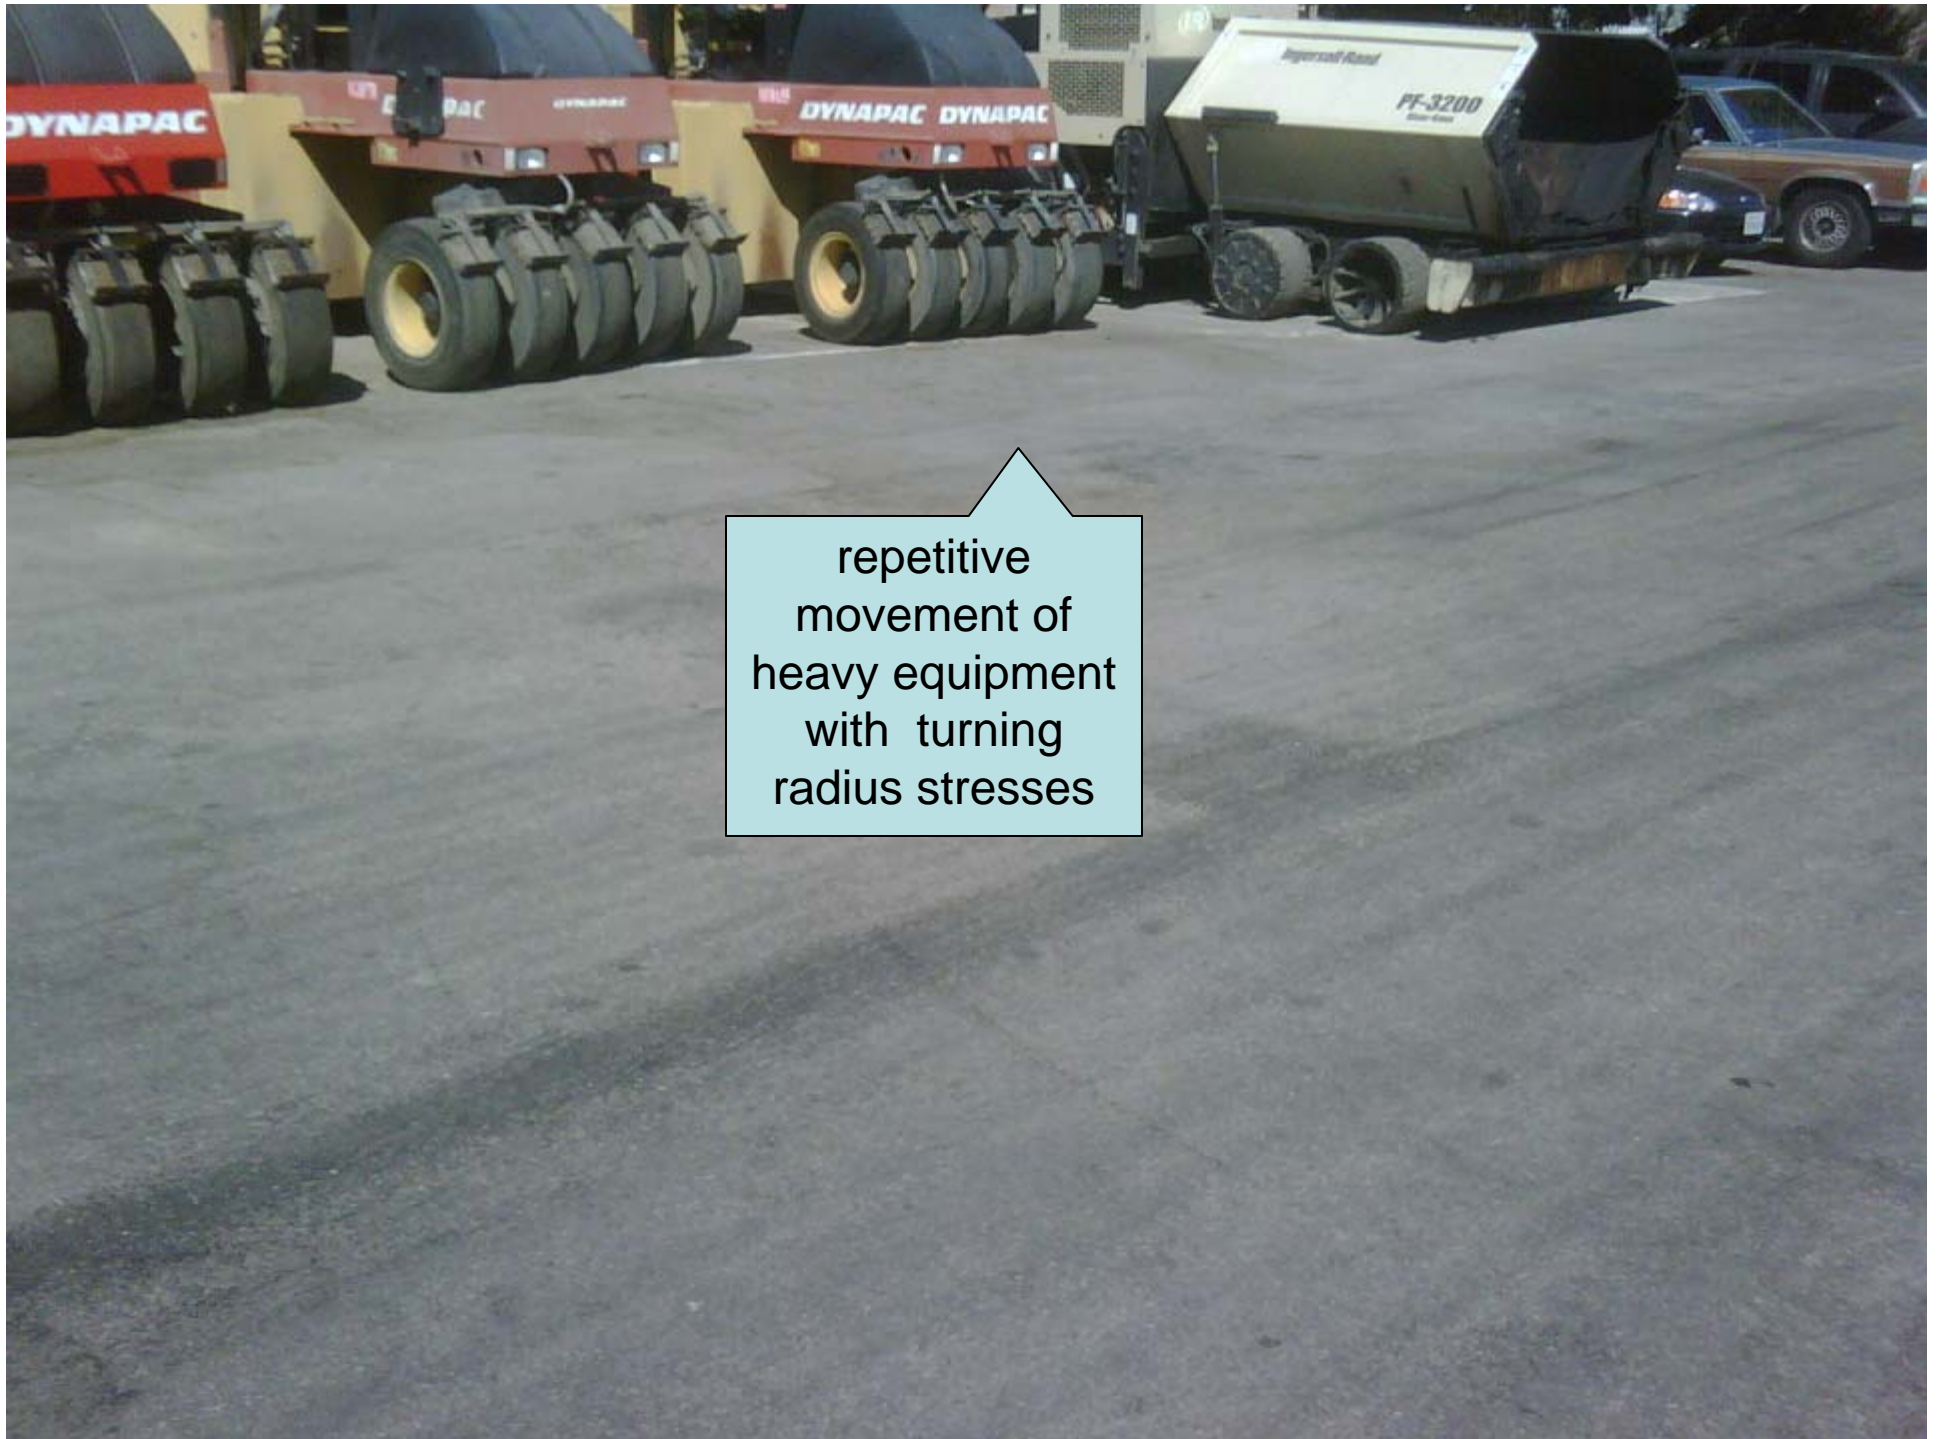
repetitive  
movement of  
heavy equipment  
with turning  
radius stresses

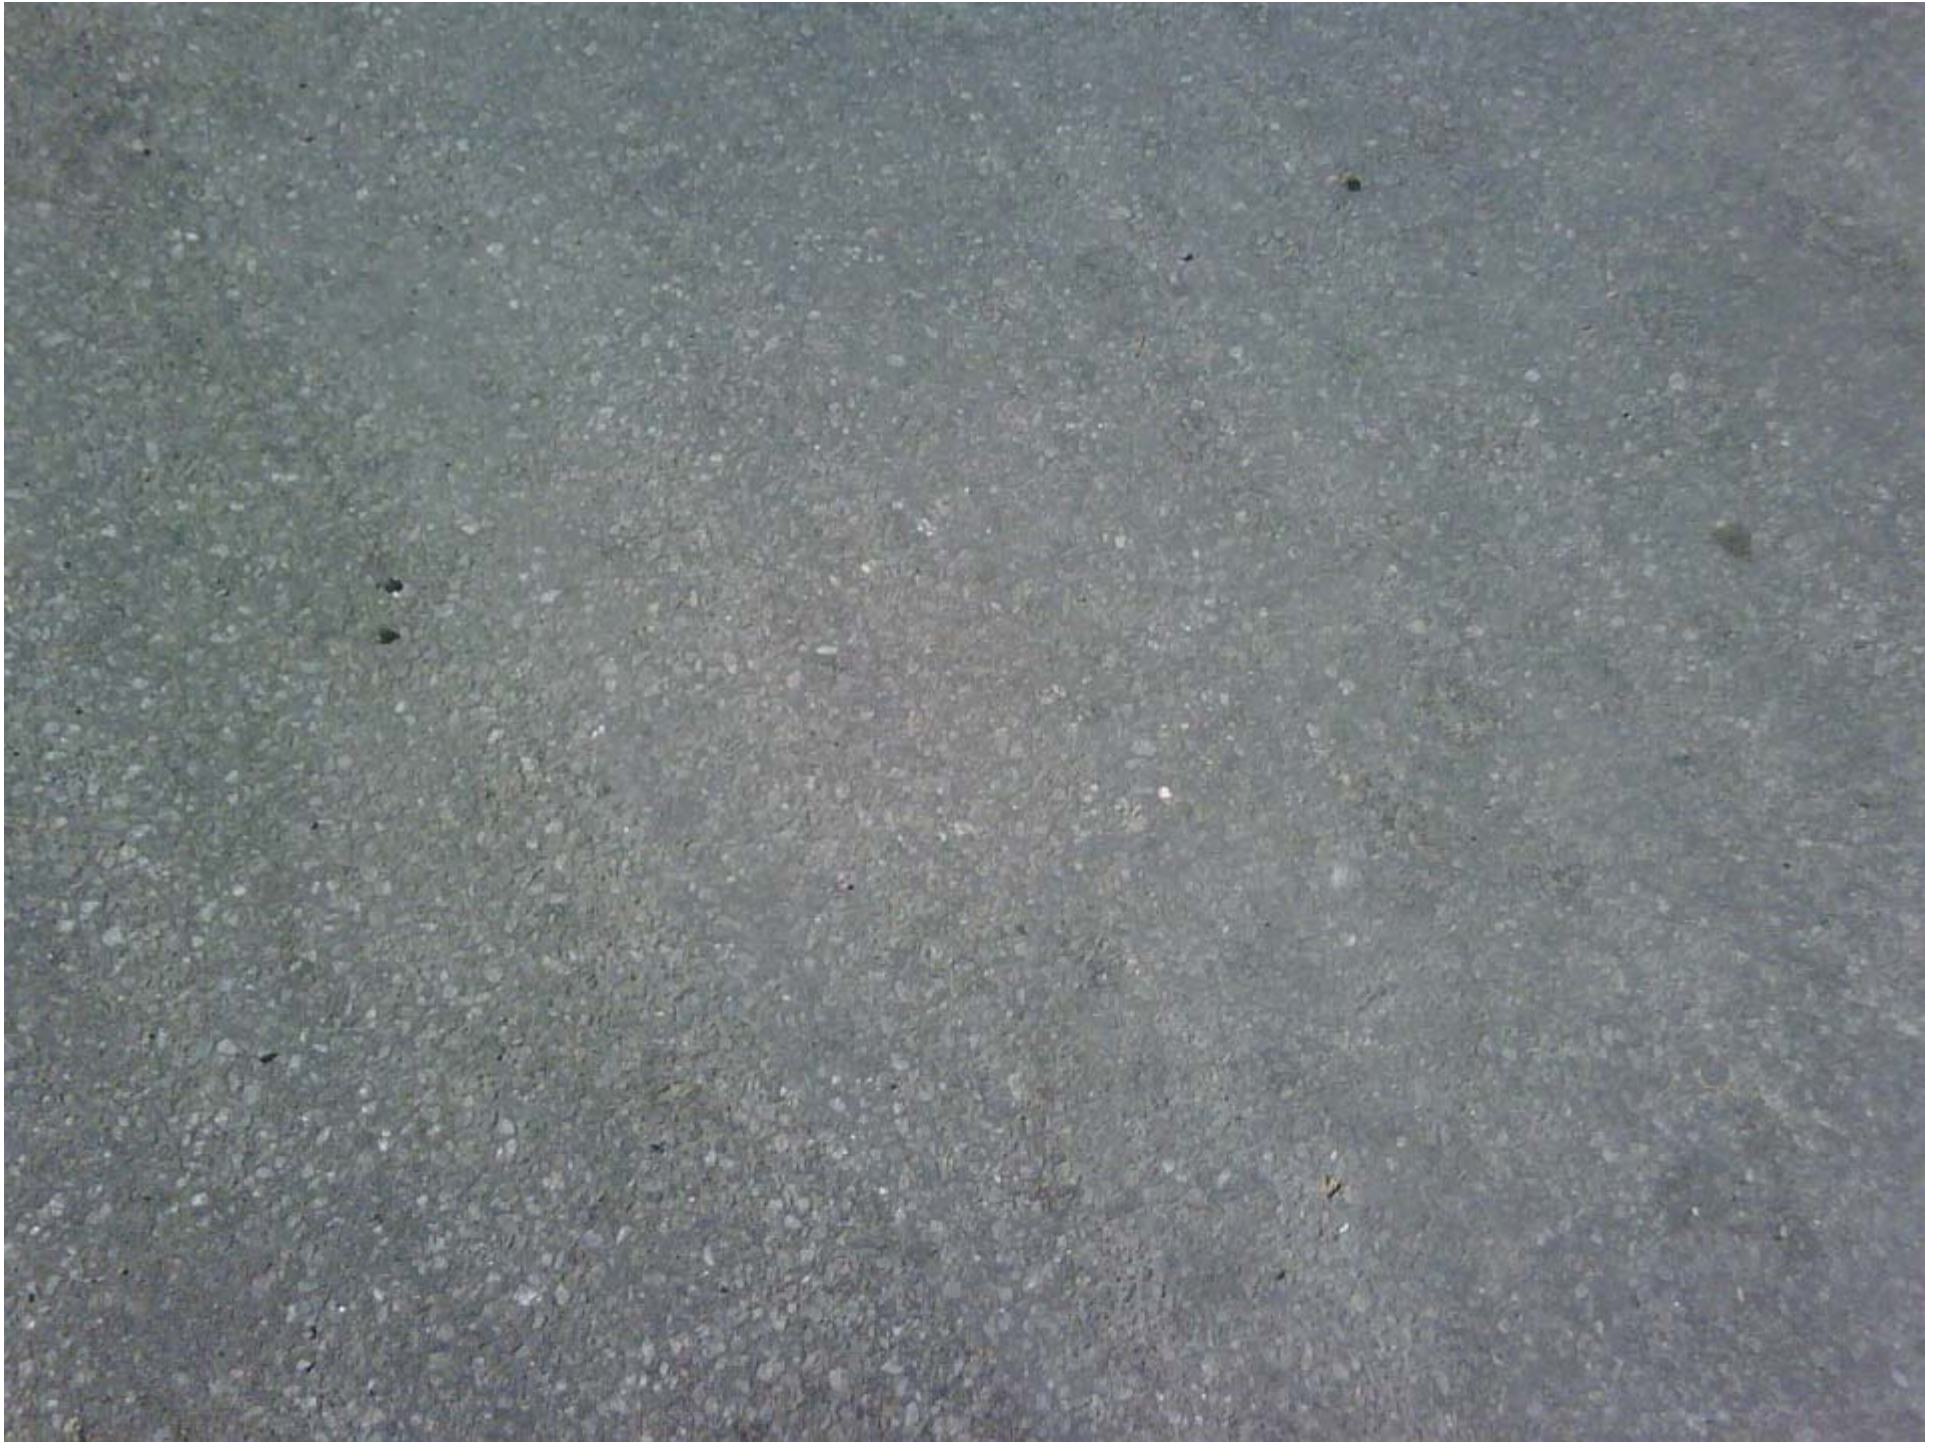
chipped

This section  
wasn't chipped  
and cracks had  
disappeared in  
the section that  
was chipped  
above the dotted  
line

Not chipped

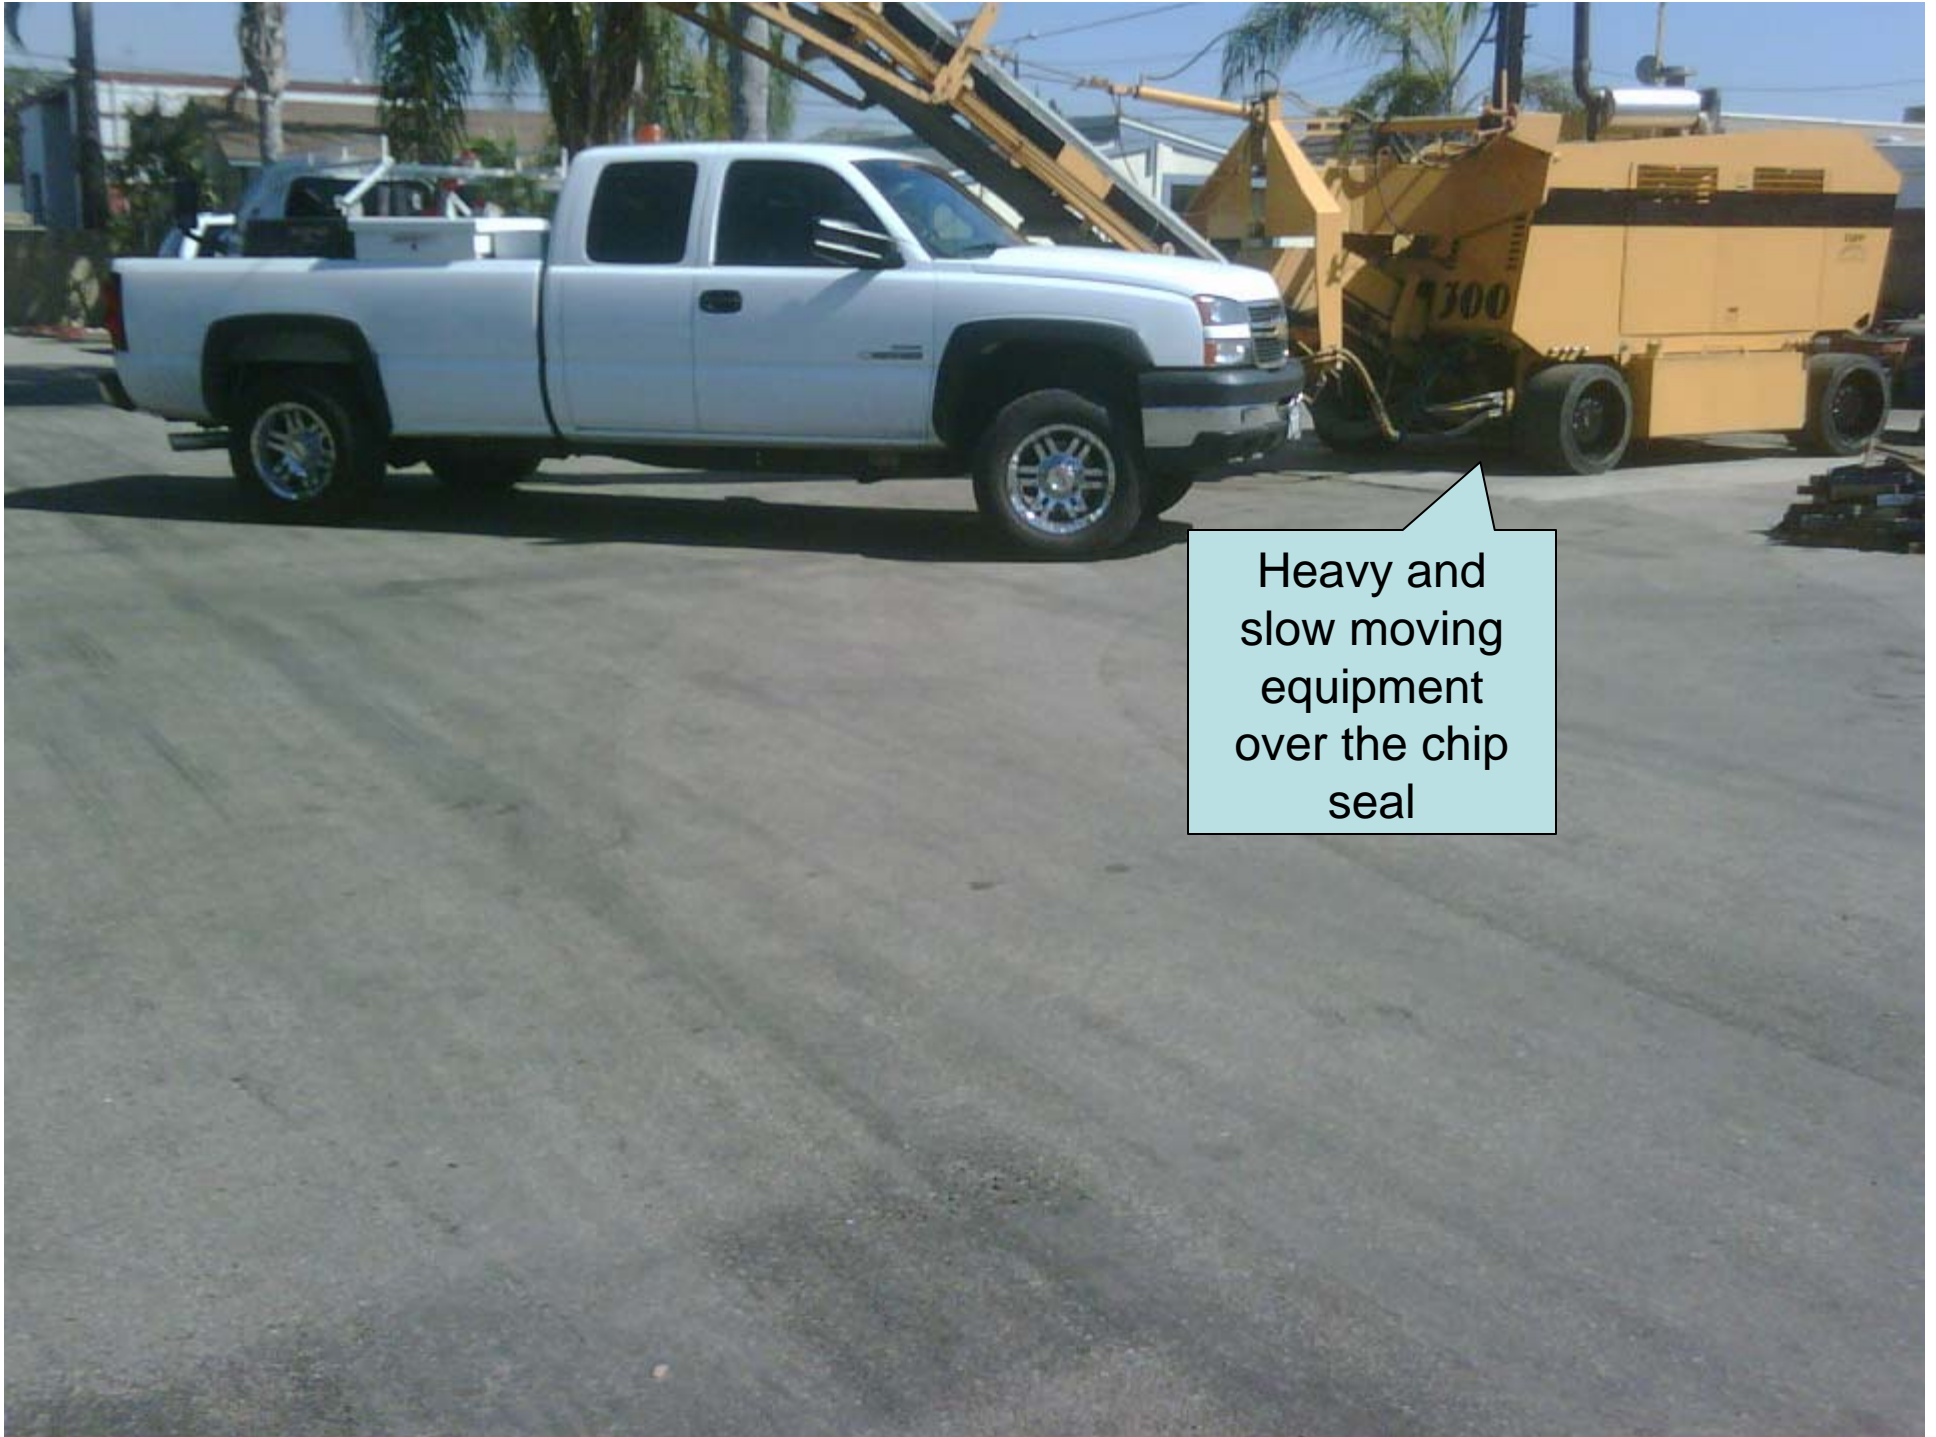
Heavy and  
slow moving  
equipment  
over the chip  
seal

Chipped section  
Good resistance  
for cracks  
propagation
